LAKE COUNTY 1989 TRAFFIC SAFETY STUDY

LAKE COUNTY

TRAFFIC SAFETY IMPROVEMENT

SEPTEMBER 1989

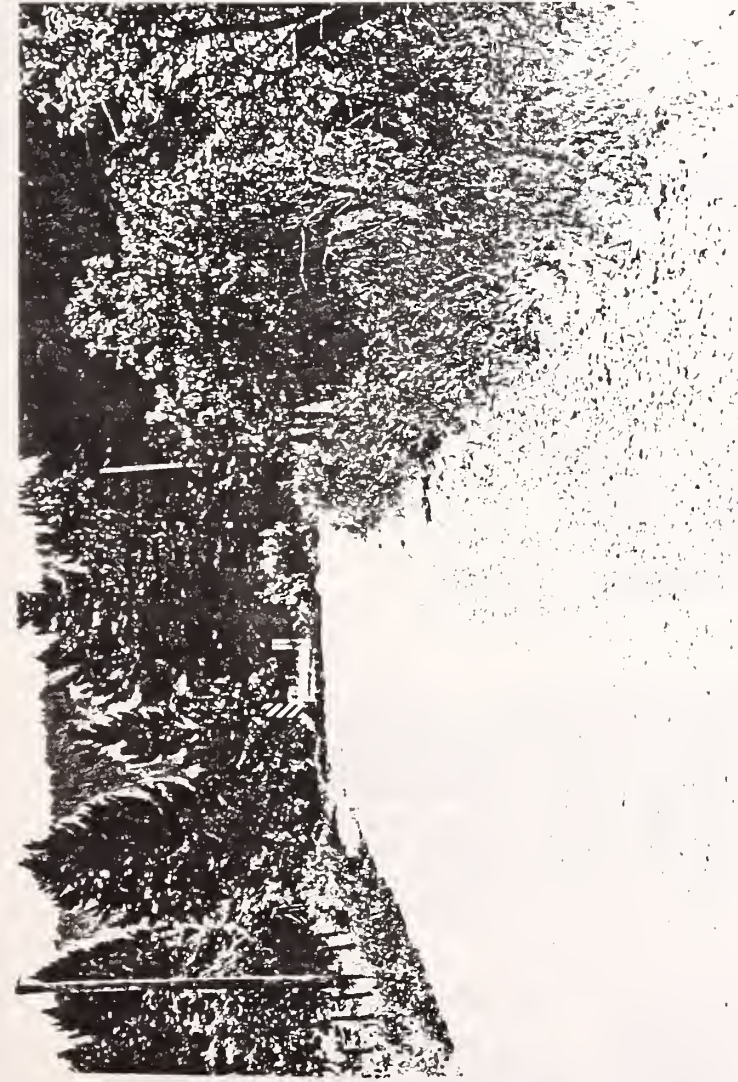
ST. MARYS 1ST CURVE, SOUTHBOUND

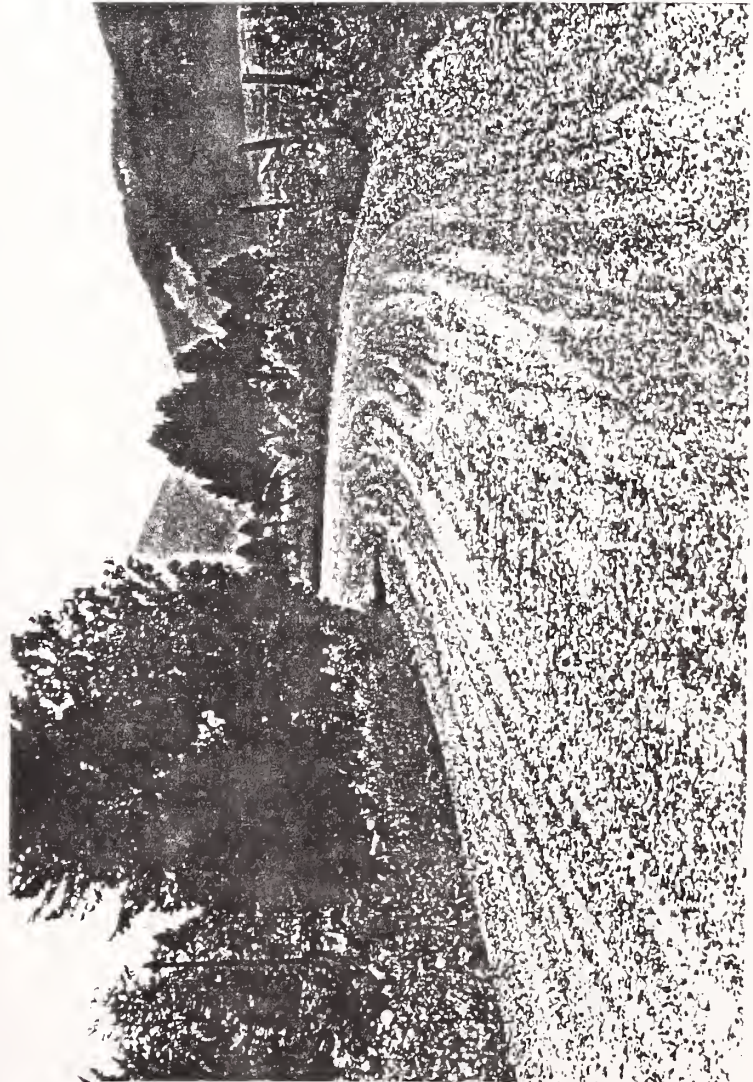
ST. MARYS 3RD CURVE, SOUTHBOUND

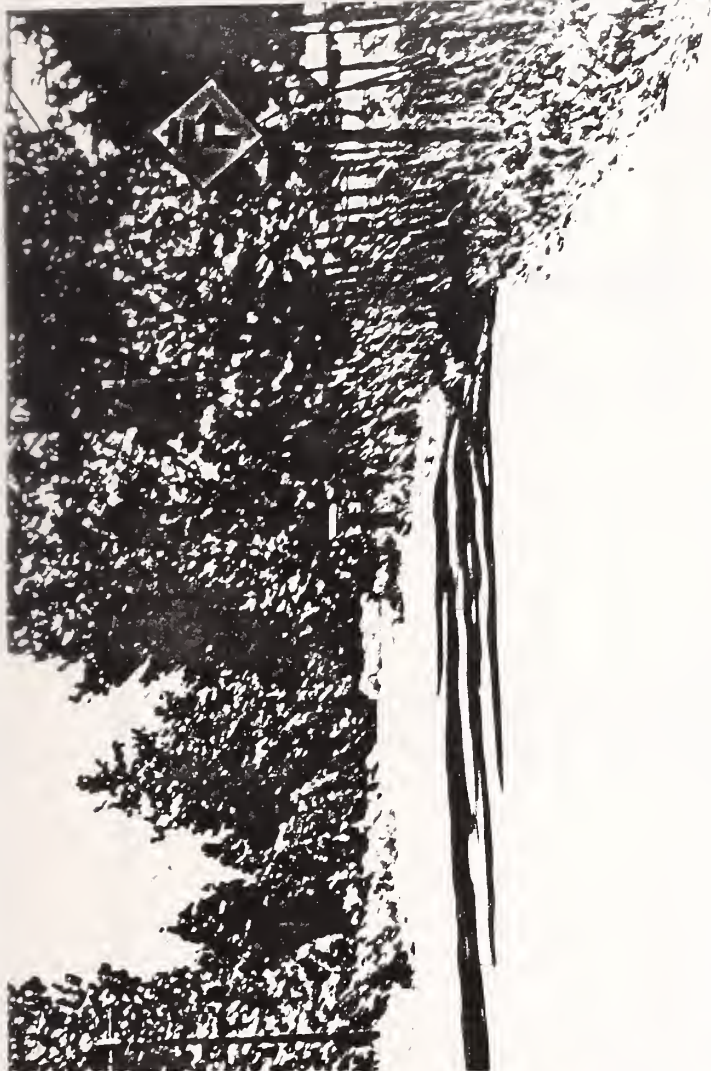
TIMBERLANE RD. CURVE @ 1 MILE, EASTBOUND
